MONITORING OF EXCAVATIONS
AT THE COMMANDING OFFICER'S QUARTERS,
FORT STANTON, LINCOLN COUNTY,
NEW MEXICO

**Monitoring of Excavations at the Commanding Officer's
Quarters, Fort Stanton, Lincoln County, New Mexico**

ARCHAEOLOGY NOTES 420

Administrative Summary

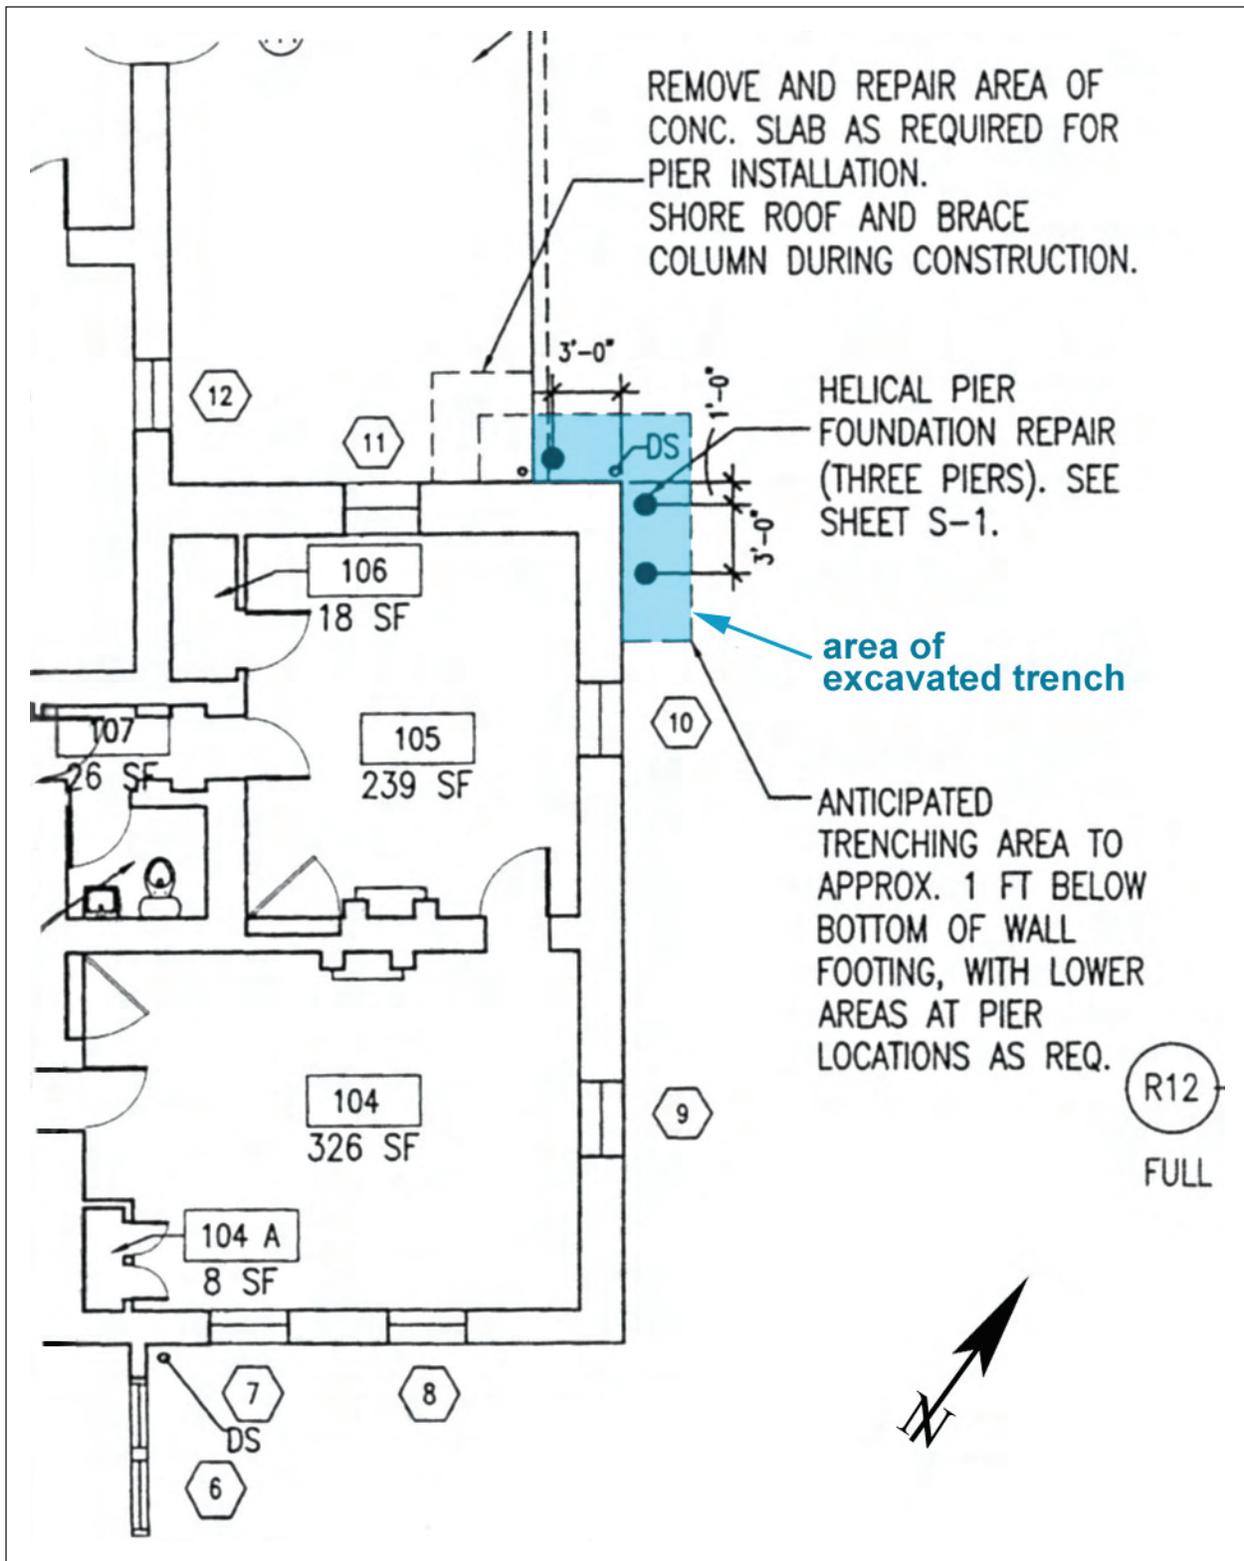
Monitoring consisted of observing the hand-excavation of a 60 cm wide by 90 cm trench on the north corner of the building (Fig. 4). This trench was 0.8 m long along the northwest wall and 1.50 m long along the northeast wall. As the trench was excavated, the fill was examined for cultural deposits, and artifacts were collected. Notes were taken describing the fill and contents of the trench as it was being excavated. When excavations were complete, profiles and a plan view were drawn to document the trench. Photos were also taken of the trench before, during, and after excavation. Once it was determined that excavations were not going to continue any further, the trench was backfilled by the contractors.

Figure 4. Schematic drawing of helical pier and excavated area.

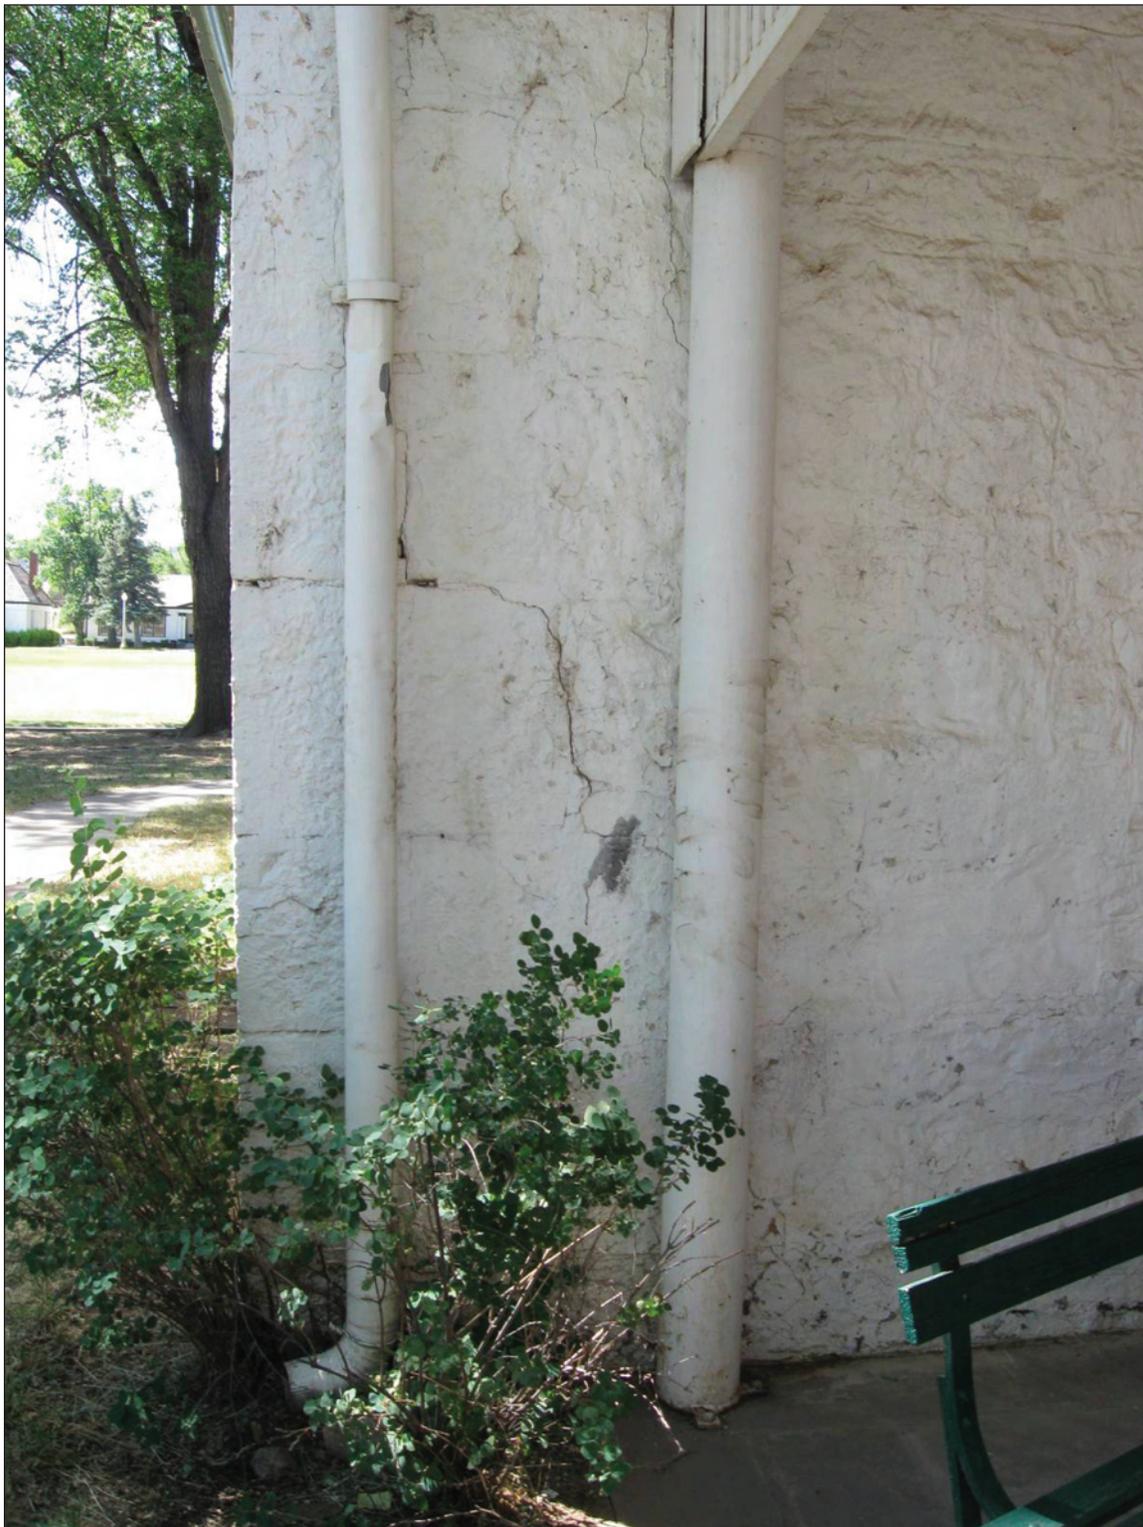
Initial observations of the wall showed that the northeast and northwest sides had a crack 1 cm wide running vertically from the base to near the top of the wall (Fig. 5). The crack in this wall had prompted the placement of helical piers at this location.

Figure 5. The northwest wall before excavation.

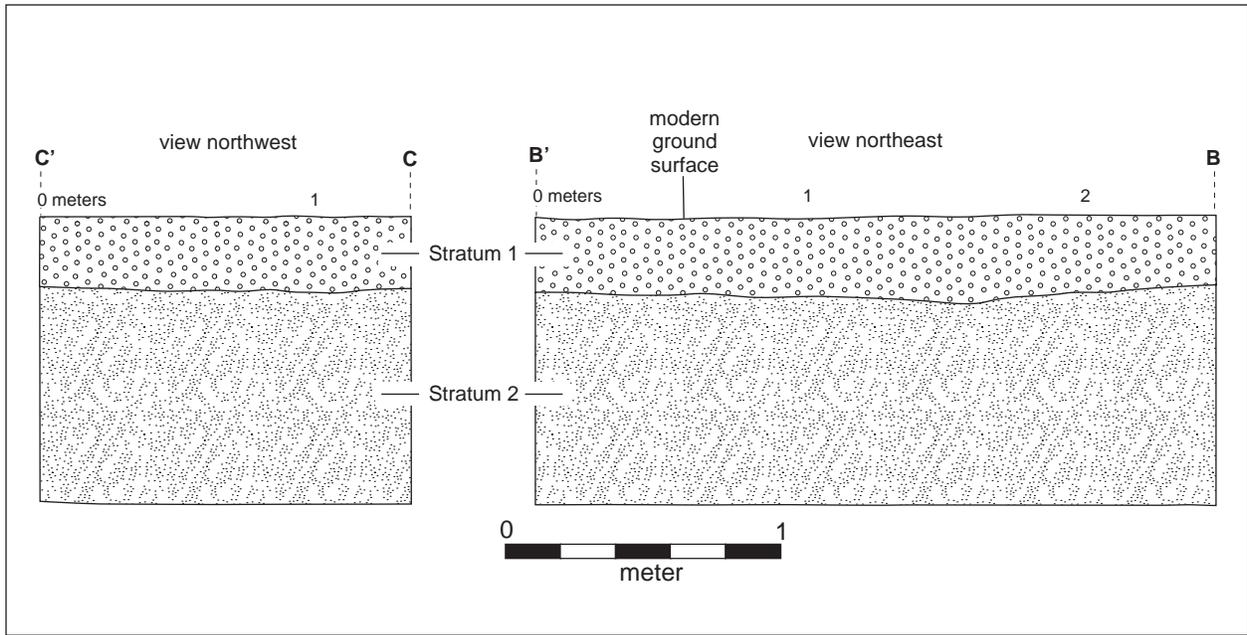
Excavations revealed two distinct strata. The upper stratum (Stratum 1) was 24–28 cm thick and consisted of a consolidated, dark brown (Munsell

10yr 3/3), silty clayish sand with inclusions of 1 percent pea gravel and roots. Artifacts and other cultural inclusions consisted of a mix of concrete and sandstone pieces, glass, metal, a peach pit, a modern key, plastic, foil, paint pieces, two Native ceramic sherds, one lithic artifact, animal bone, and very sparse charcoal flecks. Five cm beneath the surface, a loose concrete slab (56 cm wide by 80 cm long by 10 cm thick) was removed; it did not appear to be related to the construction of the building, and may have been a discarded piece from the slab in the nearby portal. The lower stratum (Stratum 2) was 68–72 cm thick and had the same consistency and content as Stratum 1, except that modern refuse was absent. Artifacts and other cultural inclusions consisted of a few pieces of glass, metal, animal bone, and very sparse charcoal flecks (Fig. 6).

Strata 1 and 2 appear to be redeposited or disturbed fill. Stratum 1 appears to be more recent, judging from the modern refuse, and may have been introduced to level the area. Stratum 2 could be as early as the building; it may be redeposited fill used to fill in the trench foundation for the building.

Figure 6. Profiles of northwest and northeast trench walls.

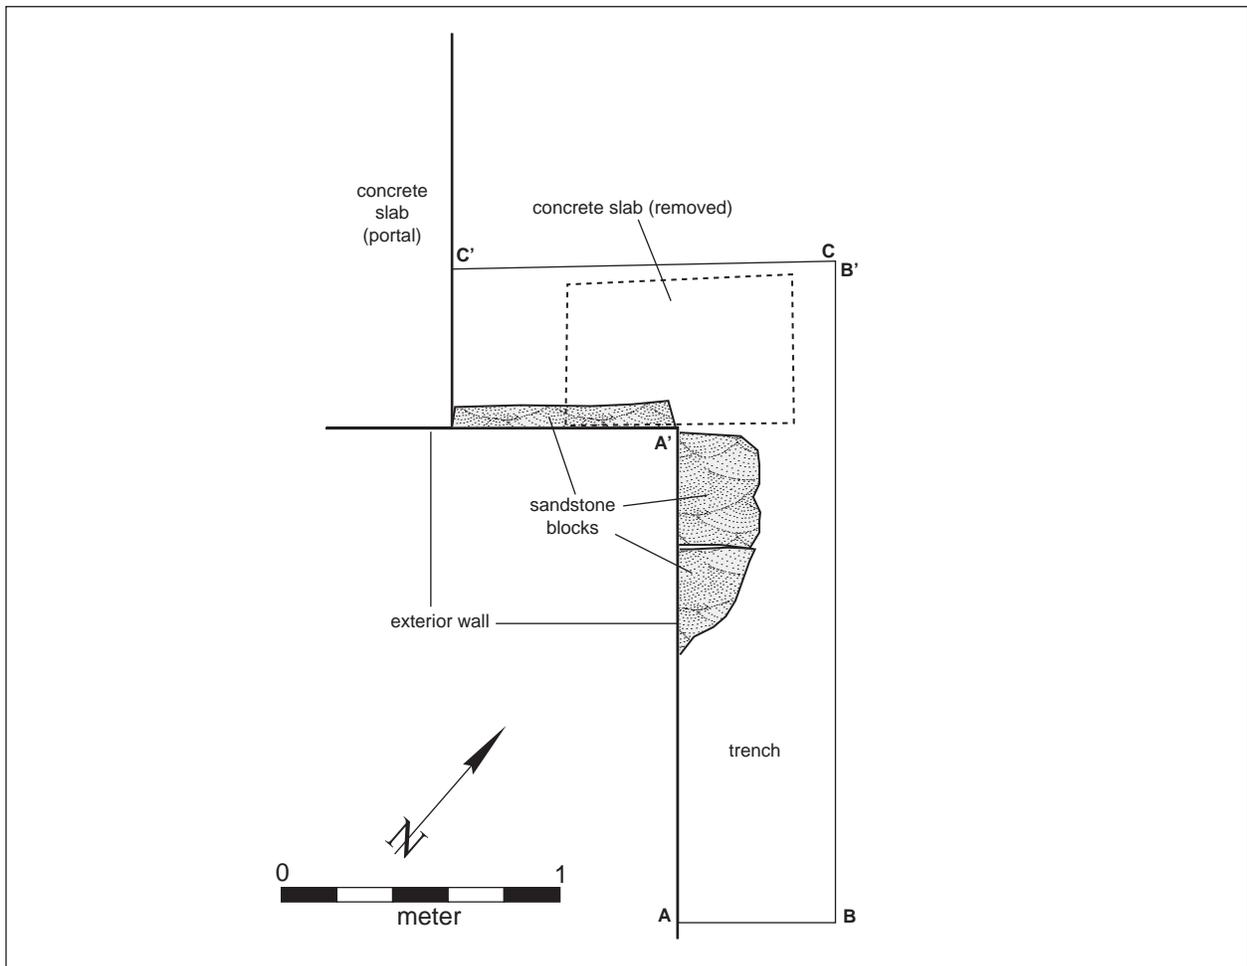
About 24 cm below the ground surface, large pieces of cut-sandstone blocks (ranging in diameter from 16 to 40 cm) were encountered below the corner of the building, protruding into the trench (Figs. 7–10). These sandstone blocks continued to 60 cm below the base of the wall. It appears that these sandstone blocks were placed beneath the corner of the building during construction to support the corner. Excavation for the helical piers could not continue because of their location, and it was determined that an alternate plan would have to be made at a later date.

Figure 7. Plan of north corner.

As anticipated, no cultural features were encountered during monitoring. Soils were disturbed and contained a mixed context. They were probably introduced during construction. Because the original plan of placing galvanized steel angle plates below the foundation was compromised by sandstone blocks, excavations were halted. A new strategy for supporting the northeast wall will have to be developed. Future archaeological monitoring will depend on what new strategy is devised. If the new strategy requires excavation in areas that were not excavated previously, additional archaeological monitoring is recommended. Future monitoring is also recommended because the depth and age of the soils are still unknown.

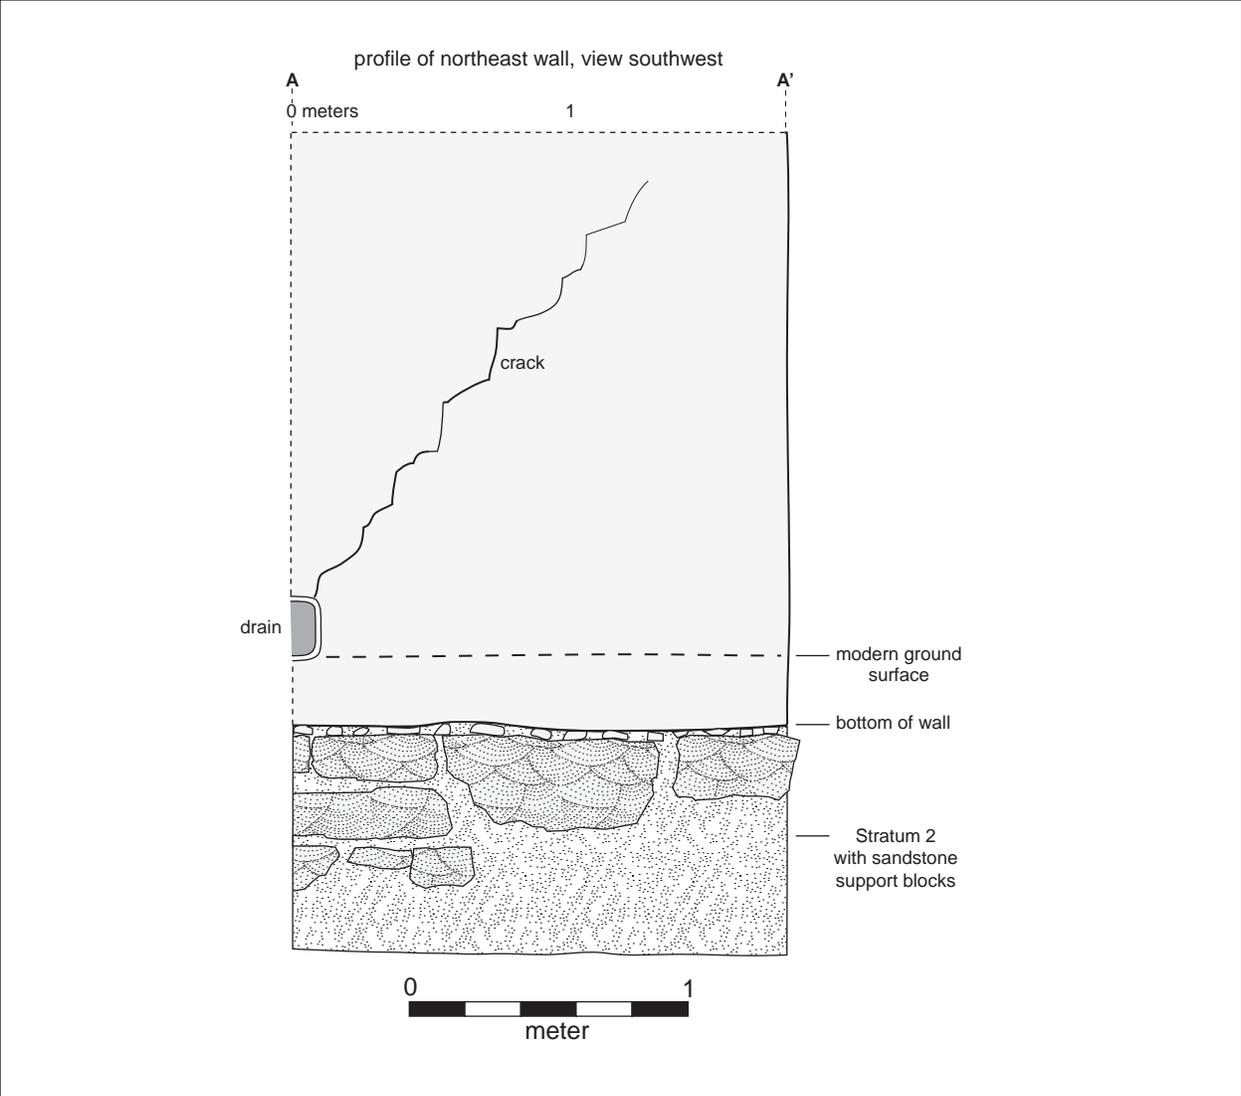
Figure 8. Profile of northeast wall.

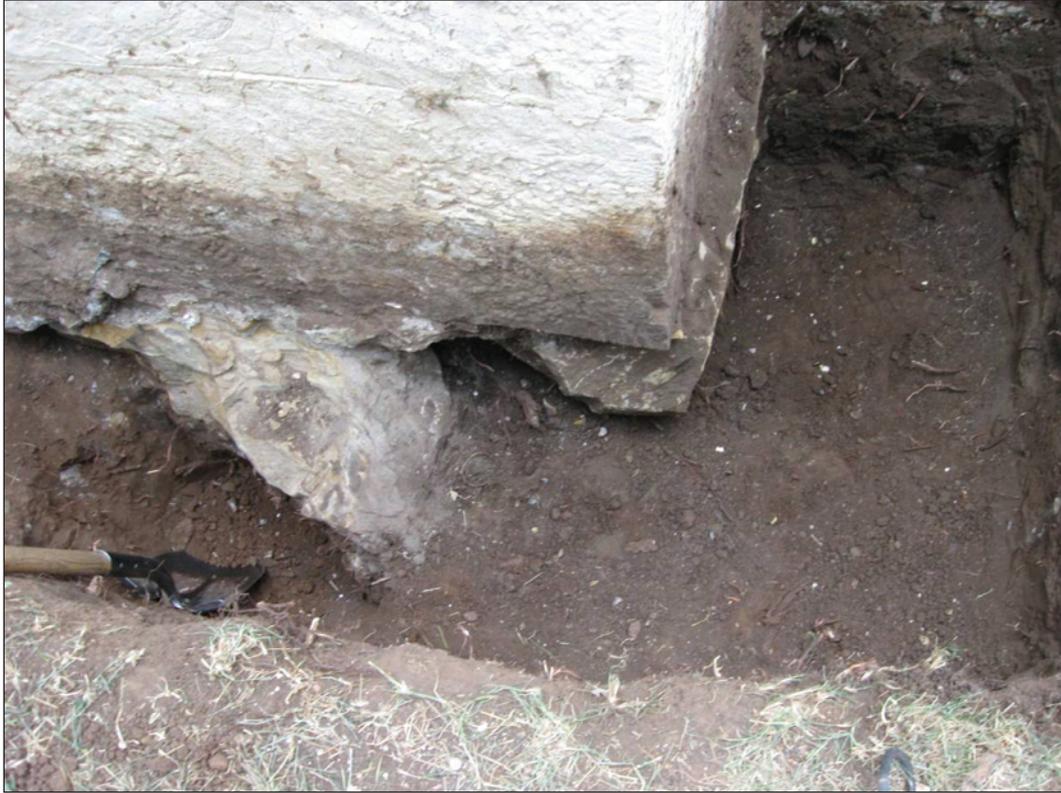
Figure 9. The north corner after excavation.

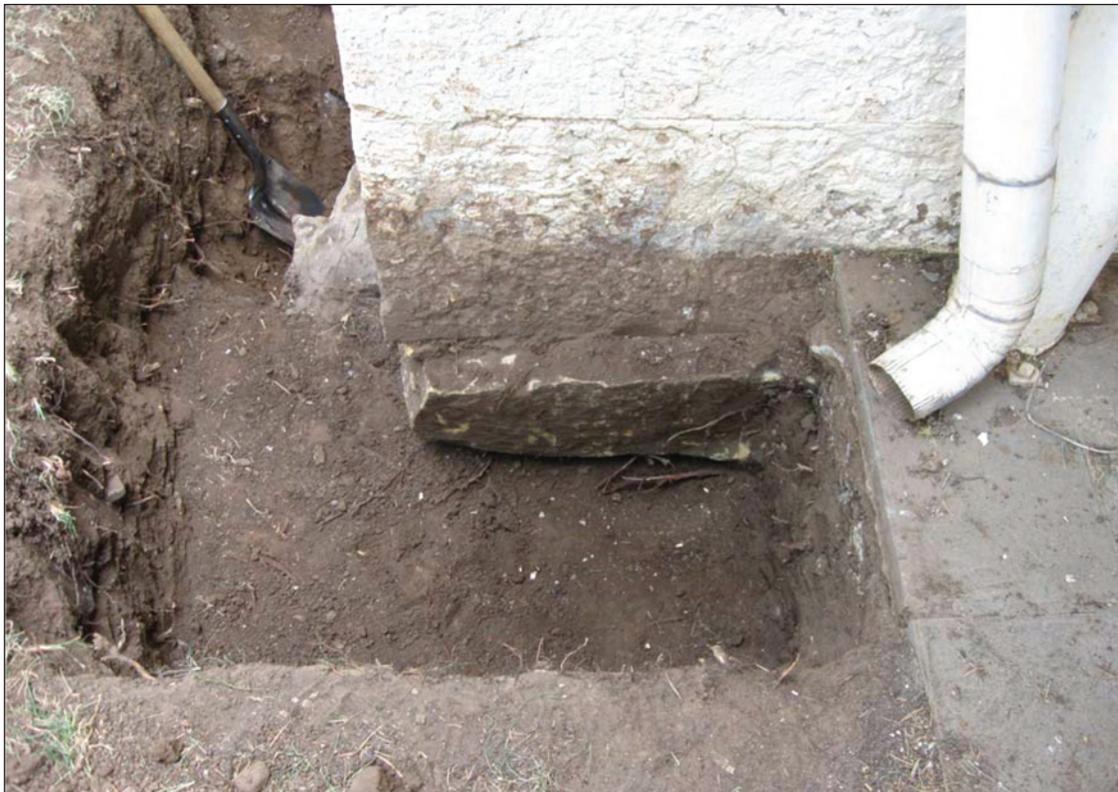
Figure 10. The northwest wall after excavation.
